How Do We Deal with Our Aging Structures?

Bruce Jordan, U.S. Army Corps of Engineers

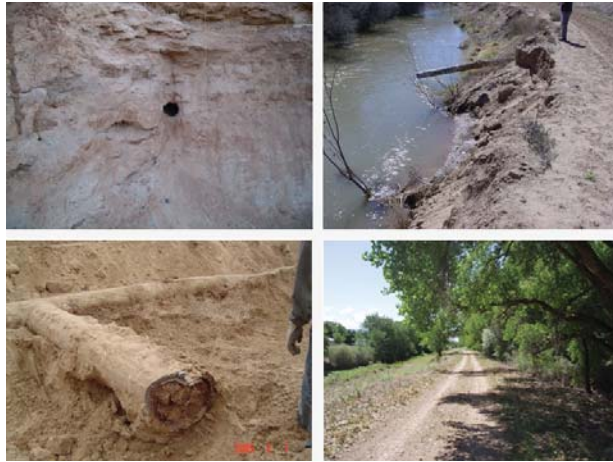
In 2005, the Corps provided a report to Congress on the condition of the Albuquerque levees. As part of that report, I, along with the other engineers in the district, surveyed those levees to ascertain their true condition. As you can see in Figure 3, we have animal burrows in the Albuquerque levees. The photos in the figure are all engineered levees. We have sloughing of the Riverside drain; the subsurface discharge pipe in the top right photo has been exposed by about 20 feet, so we've lost that. The actual drainage system has been compromised by sedimentation. And then we have our famous and lovely trees, which have been an issue for the Corps for the last five years.

Figure 3. Current Albuquerque levee conditions

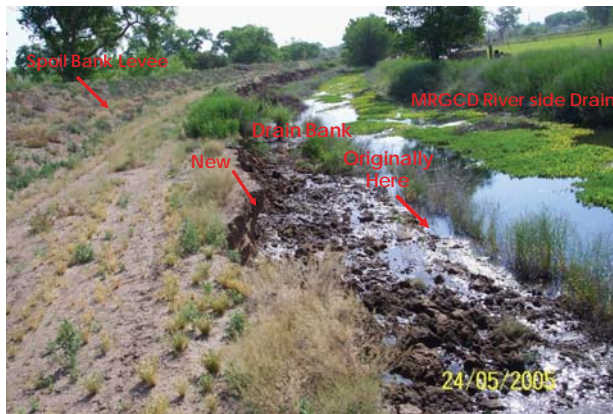
Figure 4 shows the un-engineered levee at Bosque Farms, and in 2005 we topped out on a discharge from Cochiti of about 6,500-7,000 cfs in this area. We tried to stay at 7,000 cfs for about a week, but the conditions made us back off the discharges. There was subsequent sloughing of the Riverside Drain. It was a fast occurring event so we weren't necessarily worried about losing the levee from a breach in the levee, but losing the levee from the water seepage coming under the levee (a foundation issue) and breaching the levee from it washing away from underneath was a concern.

Figure 4. MRG Levee (Bosque Farms) conditions

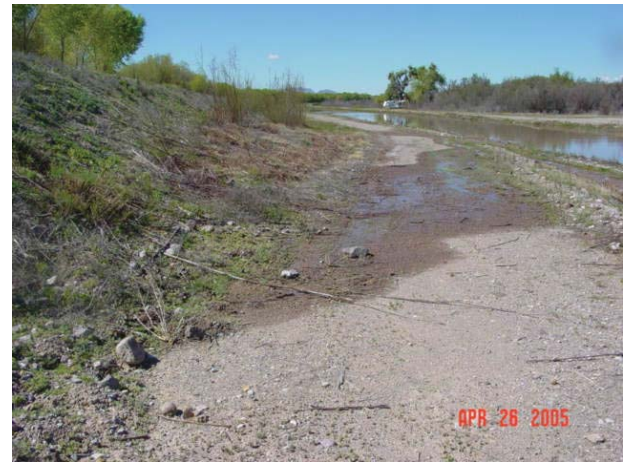
Figure 5 shows 2005 runoff in the Socorro area. The BOR had extensive problems with the way that the levee was constructed. The low-flow channel borrow material was dumped on top of the original spoil levee and they found voids within that lower section and have had to fight the resulting seepage. The actual bank of the low-flow channel

seems pretty stable, but they have experienced catastrophic failure of the levee further south of Socorro from seepage coming through the levee.

Figure 5. Socorro Levee conditions
