Monitoring Long-Term Relationships Among Surface Flow, Groundwater, and Vegetation on the Gila River

Martha Cooper, The Nature Conservancy Ellen Soles, Southern Colorado Plateau Network of the National Park Service

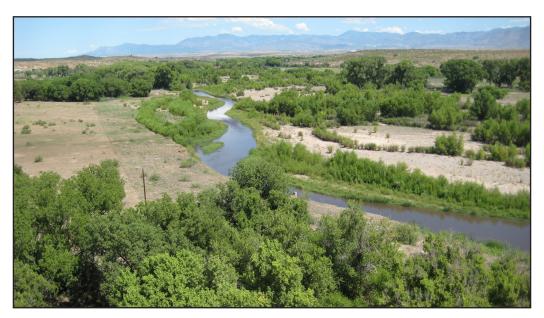
Figure 4. Total streamflow at the head of the Cliff-Gila Valley (gray line plotted on log scale), calculated from the USGS Gila near Gila (09430500) and Mogollon Creek (09430600) gauges for 2010-2016. Blue and green lines plot corresponding groundwater elevations in two wells immediately below the Mogollon Creek-Gila River confluence. Rapid groundwater response to changes in surface flow is typical throughout the valley. Surface flow is highly variable, both intra- and inter-annually; and although perennial, often drops to < 20 cfs during the driest months of early summer.

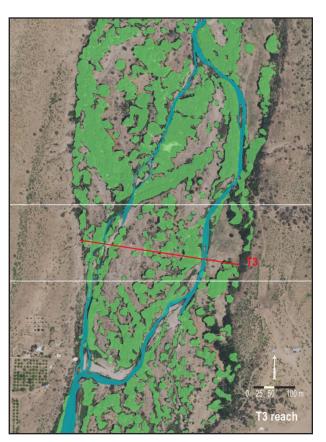
Figure 9. Riparian vegetation highlighted in segent of the upstream study area, near the head of the Cliff-Gila Valley, in 2014.

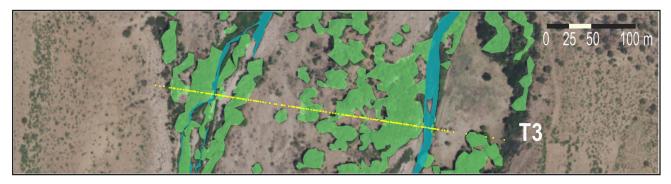
Figure 10. Close-up view of the area outlined in white in Figure 9, bracketing study transect T3. Topographic, hydrologic, and vegetation data have been collected on T3 (yellow dots) since 2010.

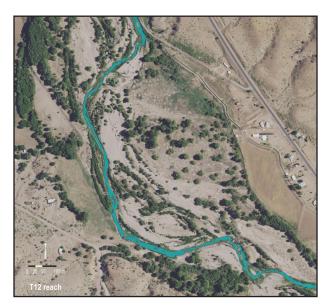
Figure 11. Downstream segment of the study area near the lower end of the Cliff-Gila Valley, in 2014. Blue shading indicates the main channel.

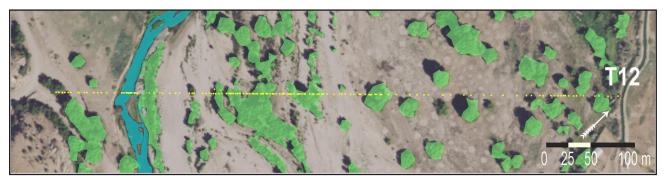
Figure 13. Close-up view of the area outlined in white in Figure 12, bracketing study transect T12. Topographic, hydrologic, and vegetation data have been collected on T12 (yellow dots) since 2010.

Figure 16. The width of each cover type or vegetation community that crosses a transect (e.g., the span of each highlighted green area in Figure 13 where it crosses the yellow dotted line) is calculated from mapping data collected during each survey. Twelve cover types are mapped, including five riparian or wetland types.

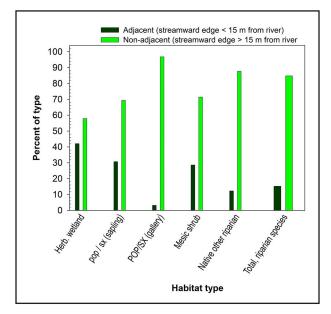
Figure 18. Percents of floodplain riparian and wetland vegetation communities located distant from the main river channel (> 15 m) versus adjacent to the river. Results were calculated from data collected on 13 study transects in 2012. Riparian habitat was five times more likely to occupy areas distant from the main channel than adjacent to it, demonstrating the broad distribution of these vegetation types across floodplains.

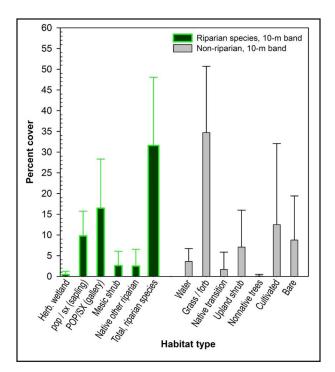
Figure 17. Total percent cover of each of 12 habitat types, mapped photogrametrically within 10-m bands spanning each of 13 study transects. Data are from 2011 aerial photography. Green columns are riparian vegetation types; gray bars are non-riparian. In total, wetland and riparian species occupy about 1/3 of the floodplain width, about the same as grass/forb cover. Young cottonwood/willow stands (po/sx) are mapped separately from gallery stands (PO/SX) to track establishment and growth over time.

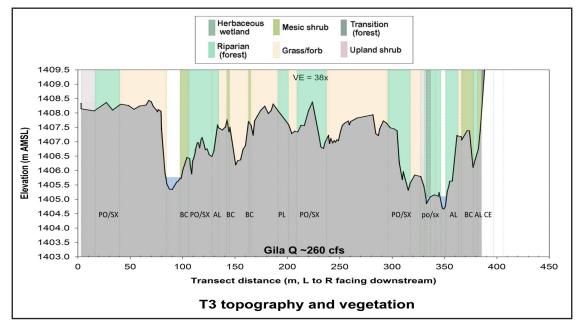
Figure 20. Depicts floodplain and channel topography on study transect T3 in 2012. Blue shading in channel represents river stage during the survey; discharge was 260 cfs. Multiple secondary channels cross the transect. T3 well positions (T3E, T3ECtr, T3WCtr, and T3W) are also shown. Continuous groundwater level data were used to calculate groundwater slopes and depths to water across the transect. Note exaggeration of vertical scale relative to horizontal scale (VE=38x).

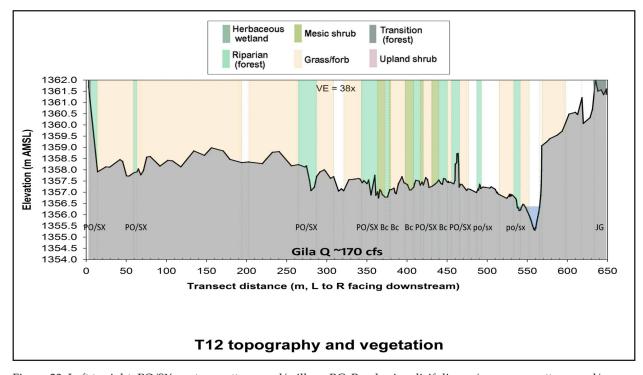
Figure 22. Floodplain and channel topography on study transect T12 in 2012. Blue shading in channel represents river stage during the survey; discharge was approximately 170 cfs. Secondary channel features are generally limited to the right half of the floodplain. T12 well positions (T12E1, T12E2, and T12E3) are also shown. Continuous groundwater level data were used to calculate groundwater slopes and depths to water across the transect. Note exaggeration of vertical scale relative to horizontal scale (VE=38x).

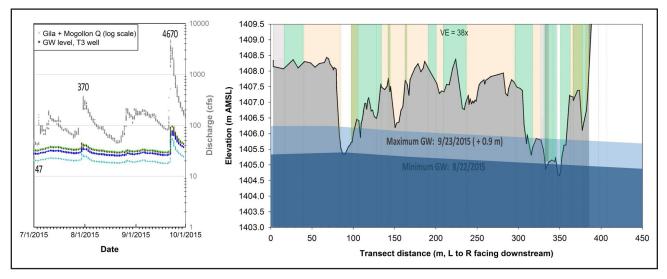
Figure 26. River discharge and corresponding groundwater level changes (left panel) on transect T3, during the summer of 2015. Minimum surface flow was 47 cfs in early July. Maximum depth to groundwater on T3 during the period occurred on August 22, when groundwater was 1.5 - 2 m below the secondary channel features on the floodplain (left panel).

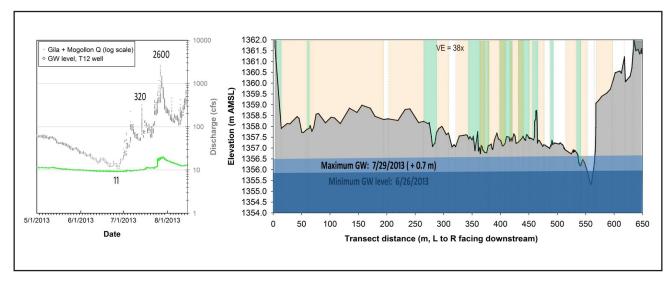
Figure 28. A similar example from the summer of 2013 on transect T12: river discharge and corresponding groundwater level changes (left panel) reflect a minimum surface flow of 11 cfs that year, in late June. Depths to groundwater on T12 during the period were greatest on June 26, 1 - 1.5 m below the secondary channels crossing the right floodplain.
