Riparian Management Effects on Flow Along the Canadian River

Jasper Brusuelas, New Mexico State University, master's degree student

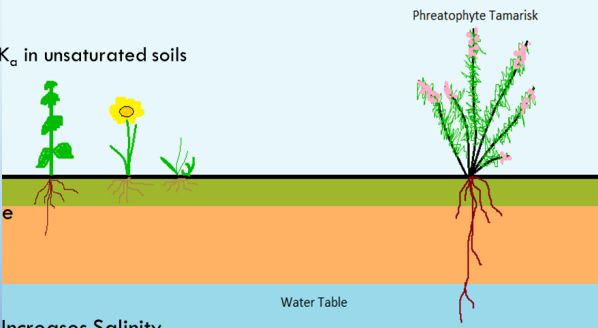
- Facultative Phreatophyte
 - Higher combined K_{rh} , k_l , K_a in unsaturated soils
- Resources
 - Light
 - Water
 - Lowers Water Table
 - Increase ET Levels
 - Soil
 - Releases Salts >> Increases Salinity

Figure 8. Tamarix spp. dominates resources.

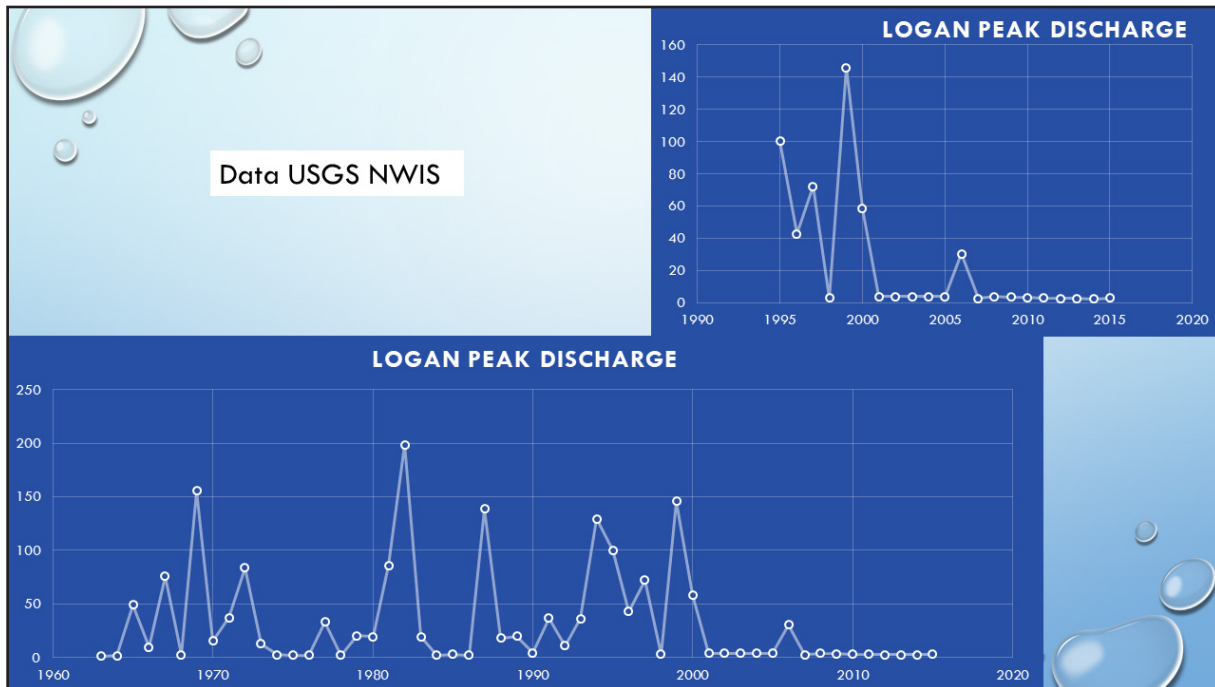
Figure 21. USGS data for Logan Peak discharge.

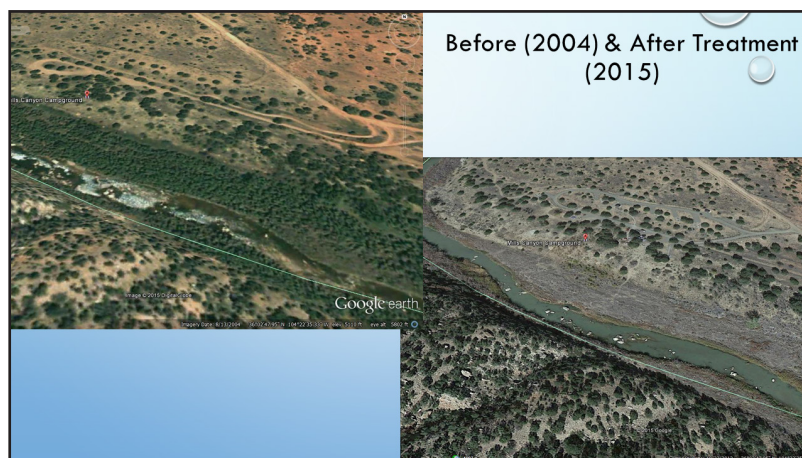
Figure 23. Before (2004) and after treatment (2015).

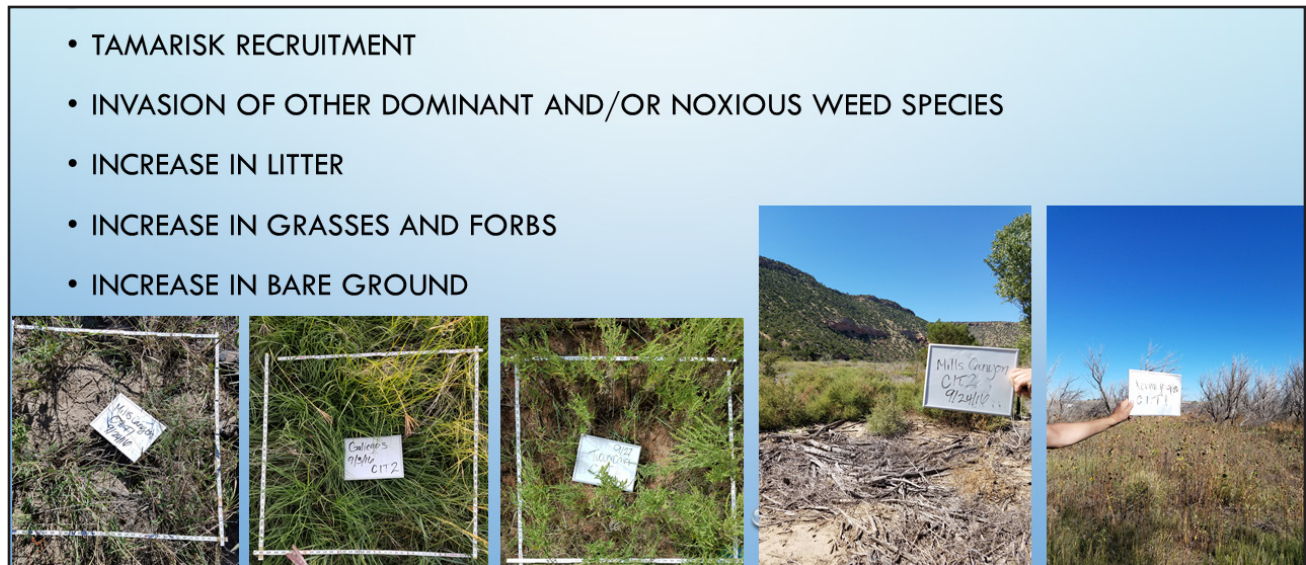
Figure 24. Response of vegetation to the treatment and removal of tamarisk in arid riparian zones; a case study of potential forage availability for mule deer along the Canadian River.
