THE RIO PUERCO - PAST, PRESENT, AND FUTURE

E. J. Dortignac¹/

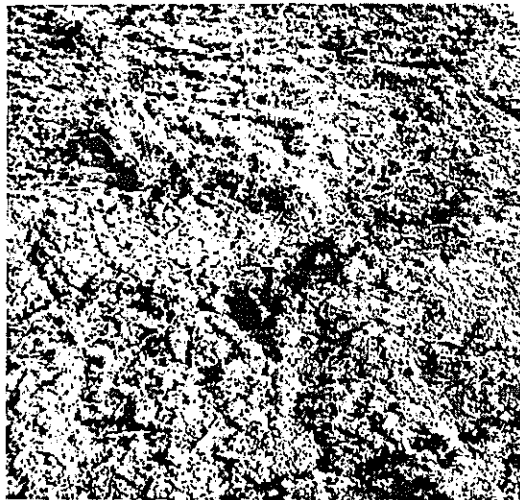
Figure 2A. Soil cracks develop on soil derived from Cretaceous shale (Menafee) after surface soil dries out. Presence of organic materials reduces the amount and size of cracks.

A good portion of the soils in the Rio Puerco, particularly those developed from Upper Cretaceous shale are subject to "piping", a form of subterranean erosion. Cracks develop in the soil or parent material due to expansion and contraction that accompanies alternate wetting and drying. Water enters and concentrates in these cracks and eventually melts or disperses the surrounding soil and forms underground conduits or tunnels called "pipes". Also, holes formed by burrowing animals and other causes contribute to the development of this system of subsurface drainage (figure 2).

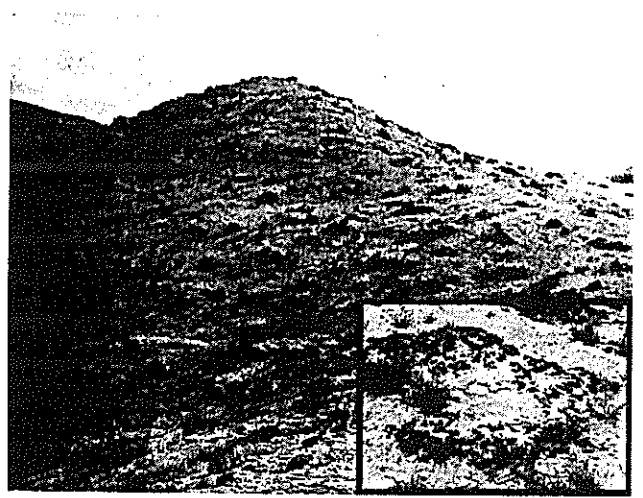
Figure 4. Mancos shale hill that once supported a good stand of alkali sacation. Note dead clumps of grass on slopes exceeding 40 percent.

Historical records and reconnaissance surveys indicate that a good cover of grass mostly alkali sacaton (*Sporobolus airoides* Torr.), galleta (*Hilaria jamesii* (Torr.) Benth.) and blue grama (*Bouteloua gracilis* (H.B.K.) Lag.) was once present over much of the watershed. This was true even in the pinon-juniper as much of this woodland is the savanna type with widely spaced trees. Steep, rocky breaks and badland topography were no doubt always barren or sparsely vegetated and contributed high surface runoff which flooded the alluvium of the valleys (figure 3). Yet alkali sacaton and other grasses covered many steep slopes and pointed hilltops of Cretaceous shale origin (figure 4). Dead root crowns of alkali sacaton can now be found on uplands and steep slopes as well as valleys.

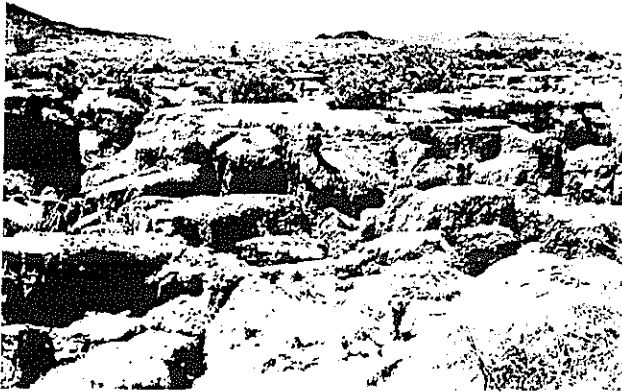
Figure 5. Gully formation in tributary of Rio Puerco in 1954.

The volume of tributary channels was estimated at 5500 acre-feet in 1885 and at 276,000 acre-feet in 1927 (Bryan and Post, 1927). It is considerably more today (figure 5).

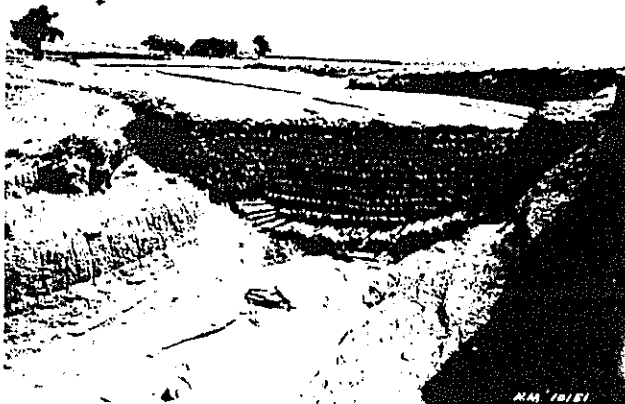
Figure 7A. San Luis Dam, 1938.

Figure 7B. Ruins of San Luis Dam, 1953.

Of 16 villages and settlements along the main Puerco Valley only Regina, La Jara, Cuba and San Luis remain populated, while La Ventana has a single family. According to Harper, Córdoba, and Oberg (1943) irrigated acreage from Casa Salazar to Cuba declined from 10,000 acres to 3,000 acres between 1880 and 1925. Irrigation along the main channel below Cuba ended with the destruction of the San Luis diversion dam by a large flood on July 25, 1951 (figure 7).

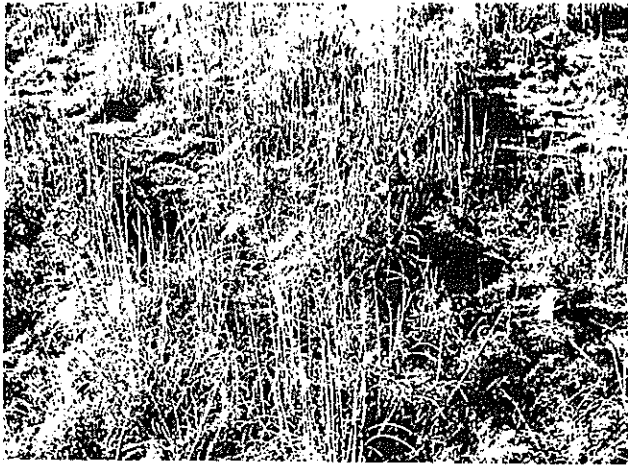
Figure 8. Stand of alkali sacaton on 15 percent slope on the Frank Bond Ranch. Soil derived from Upper Cretaceous shale.
