Clean and Healthy Rivers: Critical Resources for a Sustainable Water Supply

Chris Canavan
NM Environment Department

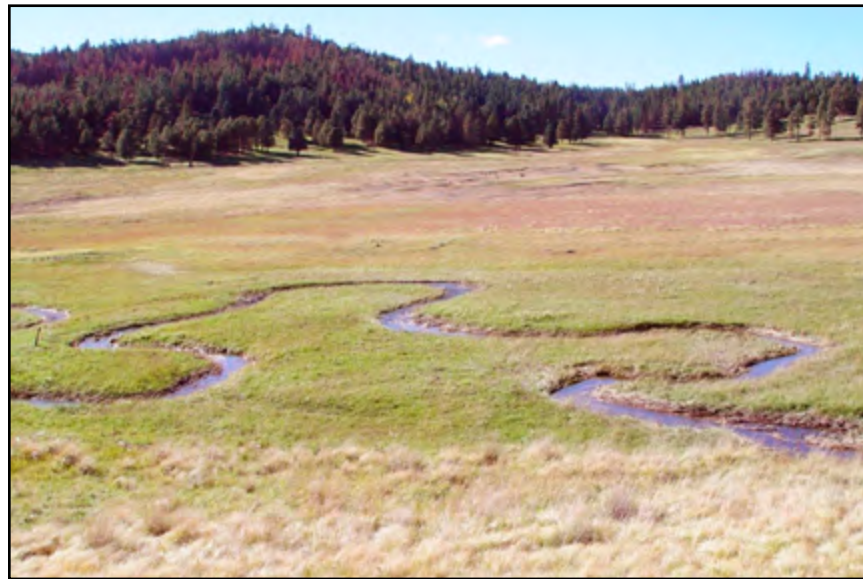
Figure 1. Jaramillo Creek provides all the services of a healthy river including flood mitigation, groundwater recharge, pollutant mitigation, aquatic and terrestrial habitat and recreation opportunities.

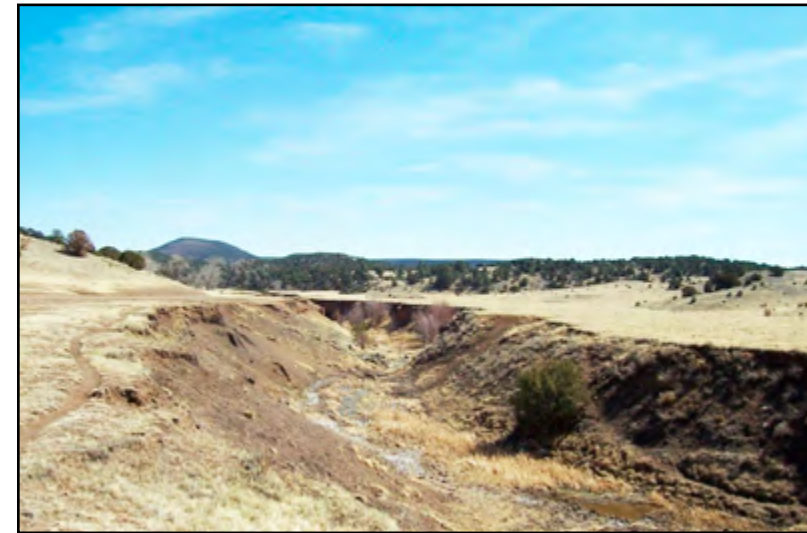
Figure 2. An incised reach of Magado Creek no longer provides water to the floodplain reducing flood mitigation, shallow groundwater recharge, pollutant mitigation, aquatic and terrestrial habitat, and forage quality and quantity.

or the loss of floodplain, and associated incision. Aggradation can occur from a change in sediment supply that leads to a depositional sediment regime as a result of events such as increased runoff and subsequent upland erosion following wildfire, increased in-stream erosion upstream of the aggradation area, and increased erosion in tributary watersheds. The result is seen in the formation of side bars, mid-channel bars, channel widening, lateral migration, and in extreme cases, channel avulsion. Aggradation also occurs behind both large and small retention structures that result from decreased flow velocities and the subsequent decreased capacity to transport sediment. Degradation can arise from a change in sediment supply to an erosional regime for a variety of reasons that include denuding of stream banks, channel modification including straightening, poorly designed in-stream structures, levees, hardened bank stabilization, and floodplain narrowing related to urban or agricultural encroachment or transportation and utility development. Most degradation is associated with some form of bank instability. In extreme cases this leads to channel incision and a disconnected floodplain.

With the onset of incision and the loss of floodplain comes a commensurate loss in services. The most significant of these are the loss of floodplain water storage capacity, reduced base flow and severely reduced floodplain forage quality and quantity. With incision also comes increased erosion, reduced flood and pollutant mitigation capacity, and the loss of both aquatic and terrestrial habitat. The combined effect of this is to reduce the amount of water available for recreational, municipal, industrial, and agricultural use and to increase the risks of flooding. Figure 2 shows degradation in the form of incision along Magado Creek in the Sacramento Mountains. The incision has resulted in a disconnected floodplain and a loss of flood and pollutant mitigation. There is also a subsequent decrease in water storage, base flow, productivity

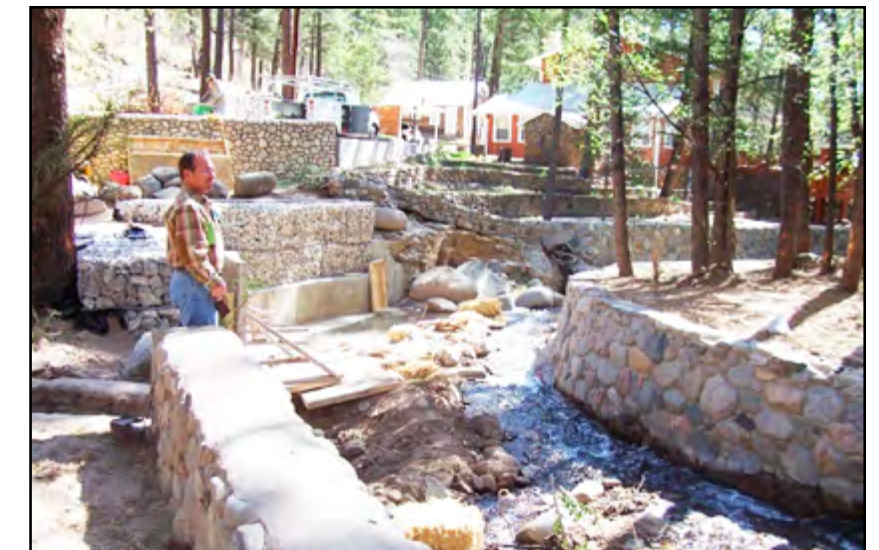
Figure 3. Following multiple attempts at bank stabilization to protect encroaching urban infrastructure, the Rio Ruidoso has been reduced to a concrete canal with loss of all natural function except water transport.

and transportation crossings can result in narrowing the river and destabilization of the bed and banks (Fig. 3). Poor watershed management can result in increased surface runoff and erosion leading to an increase in sediment supply. Dams and other channel modifications can drastically alter stream geomorphology. These impacts are often accompanied by channel adjustment that can then lead to other problems as mentioned above such as bank destabilization and incision.
