# River Restoration Activities in the Rio Grande Canalization Flood Control Project in the Lower Rio Grande, NM

Elizabeth Verdecchia  
International Boundary and Water Commission, U.S. Section

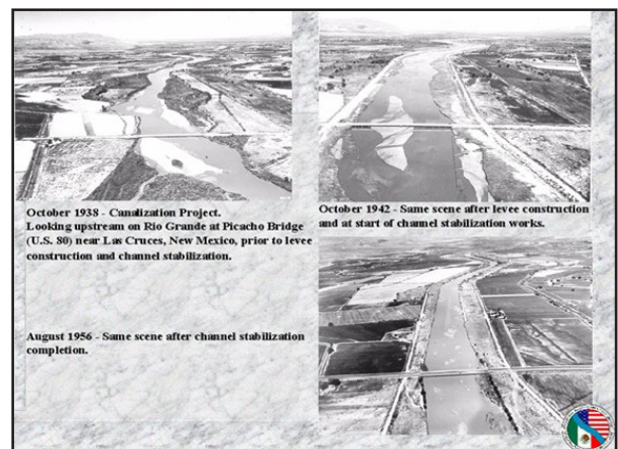
Figure 2. Las Cruces/Picacho area before and after levees were constructed and the channel was stabilized

In Figure 2, the top left picture was taken in 1938 at the Las Cruces/Picacho area looking upstream, before the levees were constructed and before the channel was stabilized. The top right was taken in October of 1942 at the same location after the levees were constructed along the side, but bank stabilization had still not occurred. The bottom picture is basically what it looks like today even though the photo was taken in 1956. There are levees on both sides and the channel is stabilized throughout. The agency has basically maintained it this way since the 1950s. We mow the floodway and dredge the channel to maintain its full flood capacity and to make sure that the project is meeting its intended purposes.

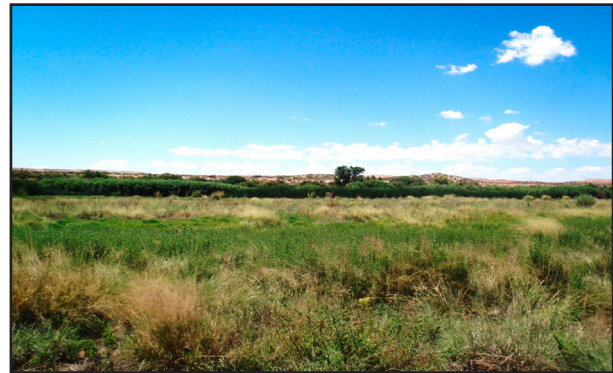
Figure 10. Crow Canyon B August 2013

Figure 10 is one of my favorite pictures, which provides an overview. You can see the river bank and the floodway. You can see many of the native grasses coming in and we have several layers of willows from different years. We do have some patches of exotic weeds, but it appears that they are being out-competed by the native grasses—a really nice grassland mosaic of the different habitats here.

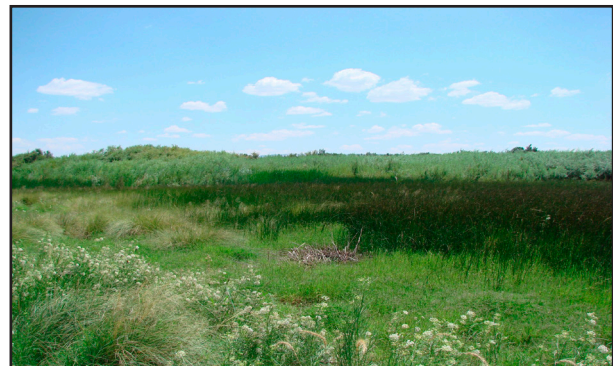
Figure 11. Crow Canyon B, August 2013

Figure 11 shows the same site but a bit closer to the river. We do have low spots with wetland areas. You can see some native brush and three layers of willows along the bank with the treated salt cedar.

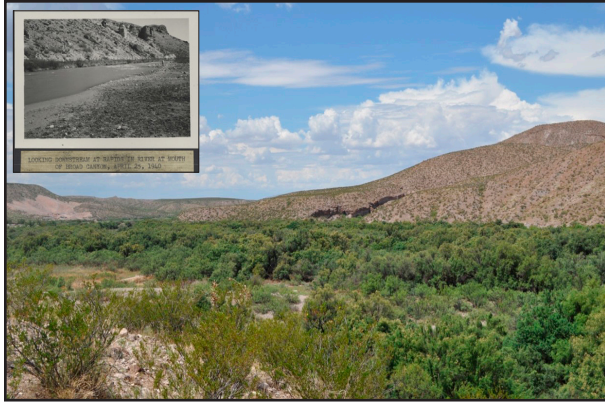
Figure 12. Broad Canyon Arroyo site

Figure 12 is a picture of our Broad Canyon Arroyo site. The top left photo shows the area near Broad Canyon Arroyo around 1940; there wasn't much of anything around the area. Site conditions have changed since: a sediment dam has been constructed on Broad Canyon Arroyo. In 2011 you can see a dense monotypic salt cedar stand. Twenty acres of salt cedar were removed by an excavator in 2012 (Fig. 13). A patch was left where the yellow-billed cuckoo had been observed.

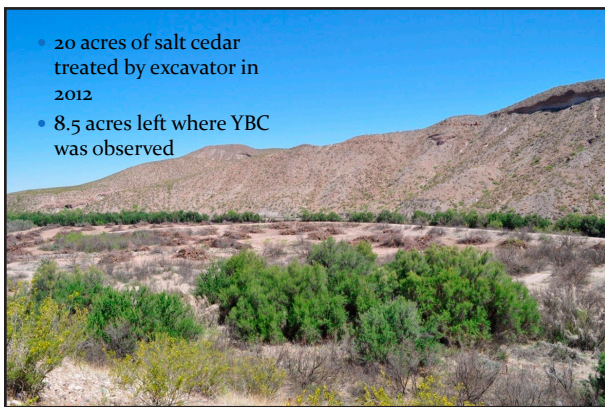
Figure 13. Broad Canyon Arroyo Site with twenty acres salt cedar removed

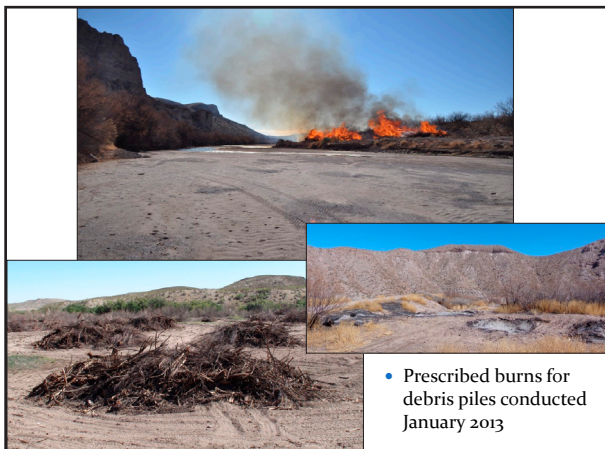
Figure 14. USFWS controlled burns at Broad Canyon Arroyo Site

Figure 14 shows piles of salt cedar debris that were allowed to dry, and then the USFWS conducted controlled burns. When the piles burned down they look something like the photo on the right. Piles were allowed to cool, and then we planted willow poles.

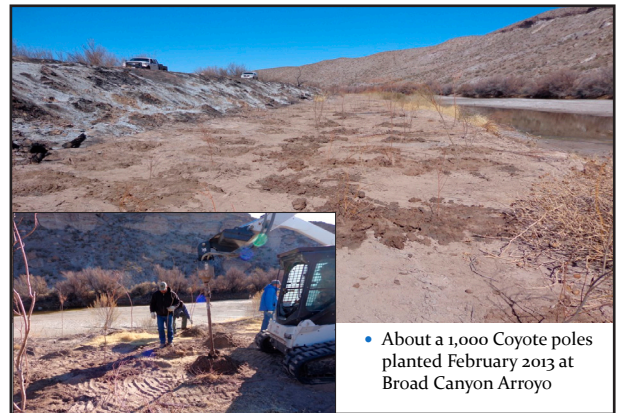
Figure 15. Lower terraces at the Broad Canyon Arroyo site ready for habitat restoration

Figure 15 shows the lower terraces that are targeted for flycatcher habitat, which consists of dense shrubs planted very close together using a deep auger. This one is actually eight feet long. Willow poles are harvested from mature willow stands and put into water for a couple of weeks. Then they are planted in eight-foot auger holes where, technically, their toes are in water year-round, grow roots, and then hopefully they take off and sprout. Figure 16 shows trees that are coming up along with native vegetation. Wolfberry and native grasses are in the foreground. At this site, we planted nearly 1,400 willow trees and 105 cottonwoods.

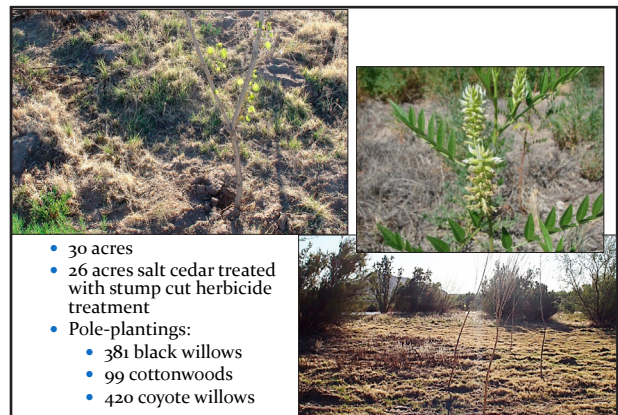
Figure 16. Leasburg Extension Lateral

Leasburg Extension Lateral site near Las Cruces is show in Figure 16. You can see cottonwoods and some of the native poles that we planted. Native vegetation is coming up because we aren't mowing. At this 30-acre site, salt cedar was treated on twenty-six acres. We planted 400 black willows, 99 cottonwoods, and 420 coyote willows.

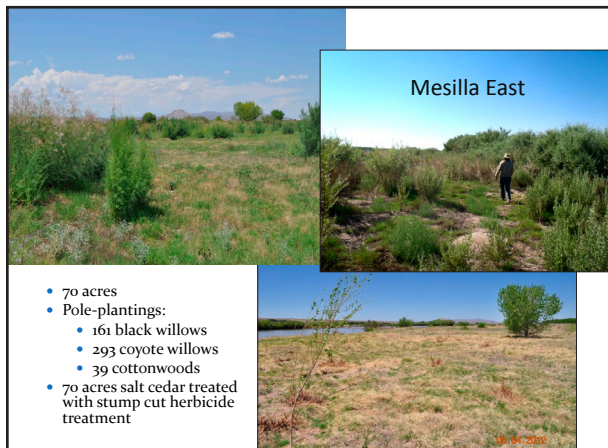
Figure 17. The Mesilla East site

The Mesilla East site is very close to Leasburg site (Fig 17). The top left photo can be considered a “before” picture and you can see the treated salt cedar piles. On the top right is a recent picture. Look at all of the willows that are coming up on their own from the riparian zones.
