# Flood Control in an Urban Area: Challenges for AMAFCA

John Kelly, Albuquerque Metro Area Flood Control Authority

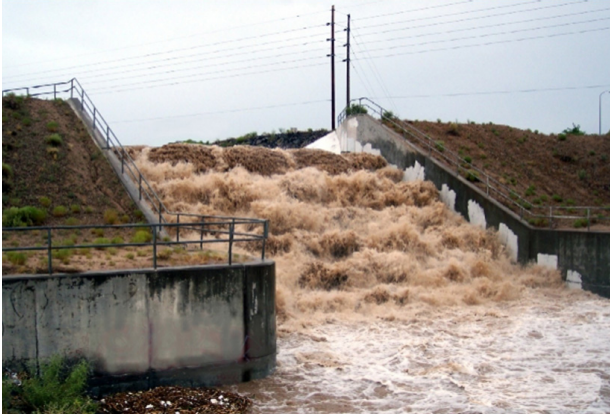
Figure 1. South Diversion Channel Drop Structure

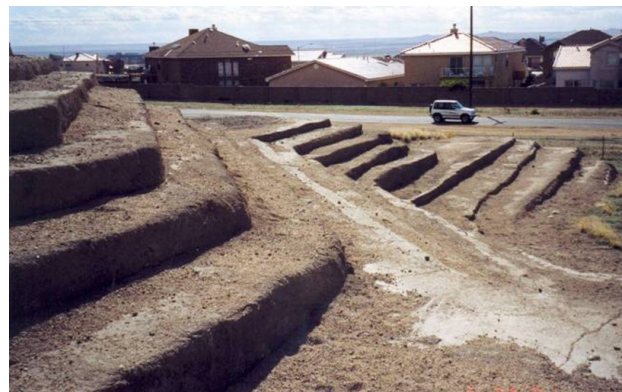
Figure 3. Kinney Dam Spillway

We have also used soil cement extensively on our projects. Figure 3 shows Kinney Dam spillway designed by RTI. They did a great job on this project. The soil cement is alluvium right out of the bed of the arroyo, mixed with about 7 percent cement, enough water to hydrate it, and then it is placed with heavy earth-moving equipment. Those lifts on the spillway are 10 feet wide so we are making up in mass what we lack in rebar. The soil cement breaks at about 1,500 psi compared to 3,000 or 4,000 for concrete, and it looks like a nice set of sandstone layers.

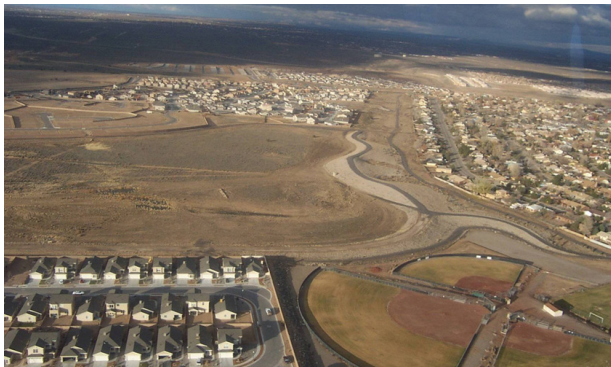
Figure 4. Las Ventanas Detention Dam

We are the first agency in the state to landform a flood control dam. If you look at the crest of Las Ventanas Detention Dam, designed by Bohannon Houston, you see the crest varies horizontally and vertically. We don't have that long linear crest of the dam and it blends into the landscape better (Fig. 4). We have also varied the slopes by putting aesthetic fill beyond the structural fill so we can actually bring landscape in on a dam embankment (Fig. 2). We were able to build layers of geology into the Calabacillas Arroyo. On the West I-40 Diversion Channel project we have schools of salmon swimming upstream, if you can imagine that (Fig. 5). We are well known for the multi-use aspects of our facilities; we have bike trails up and down 60 percent of our flood control channels in town. It is a great independent transportation system off the highway grid. Our dams serve as anchors for parks, golf courses, and hang gliding areas all over town. At the Kinney Dam, we designed the dam with a two-stage pool, pre-sized for a future soccer field to be worked into the regional park complex. We also set the dam ramps at 20% slopes to meet future ADA requirements and to allow everyone access. With early coordination on the project, we enhanced its future multiple use.

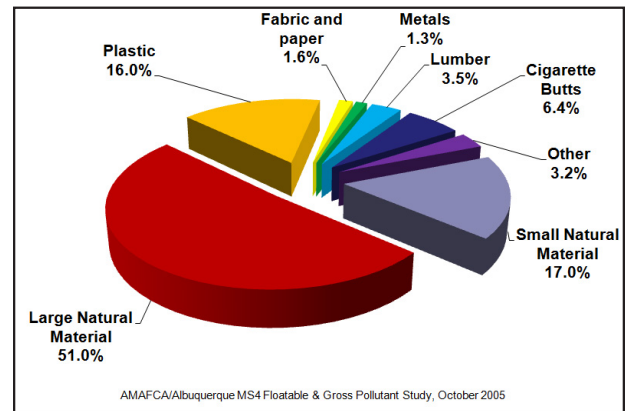
Figure 6. Gross Pollutant Study Debris Characterization by Volume

Under the permit, we were required to conduct a gross pollutant study in which we characterized trash. We collected material from City pump station bar strains and we screened trash out of the arroyo system. We characterized the sample by volume. Figure 6 indicates what we found. Large natural materials and small natural materials (tumbleweeds, leaves, pine needles) made up 68 percent of the debris flow. Plastics made up 16 percent of the total, mostly those little water bottles we all like so much. Cigarette butts accounted for 6.4 percent and I think that was probably a function of the screen size that we used, but that surprised us all.

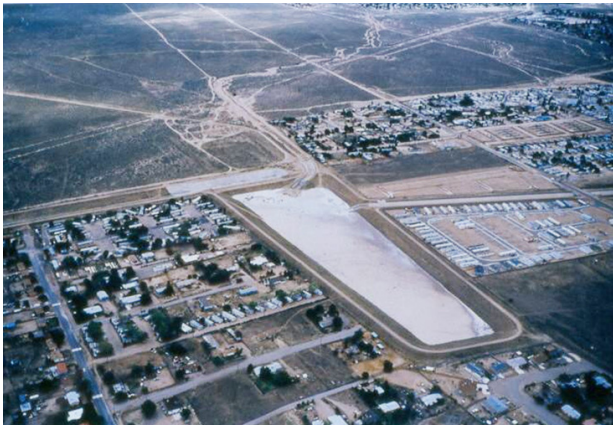
Figure 7. Amole Dam

What we have done on debris removal? We had some good learning experiences with our existing system. Amole Dam, built in the mid-70s on the west side, fills with water, and drains down into the conservancy district's canal (Fig. 7). After the dam drains, you can typically see the accumulated trash, and we wondered why the trash was just sitting down there (Fig. 8). We took a better look at it and realized the ports were on an incline just like the baffle on a septic tank. So that was an easy solution for dams – just put inclined ports in the principle spillway outlet (Fig. 9). Our dams had a simple bar screen across the principle spillway pipe so we went in and modified quite a few of them with the inclined riser. Figure 10 shows a completed project at the South Baca Dam.

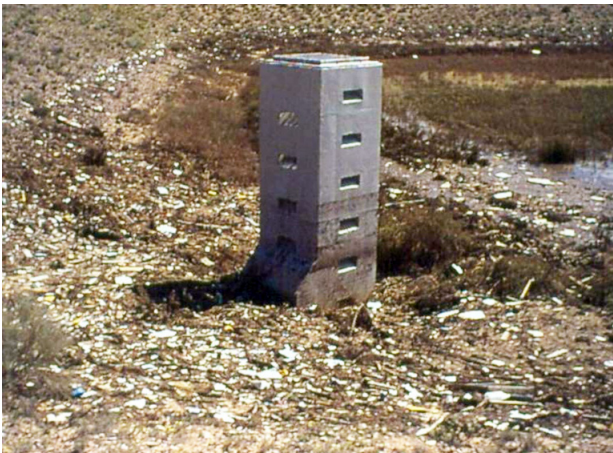
Figure 8. Trash Collector at Amole Dam

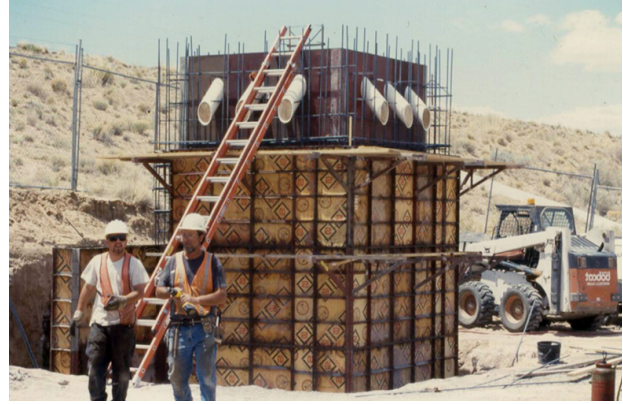
Figure 9. Inclined Port Spillway Tower at South Baca Dam

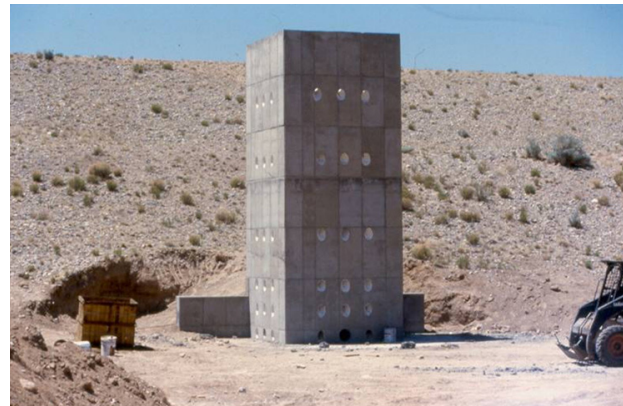
Figure 10. Completed Inclined Port Spillway Tower at South Baca Dam

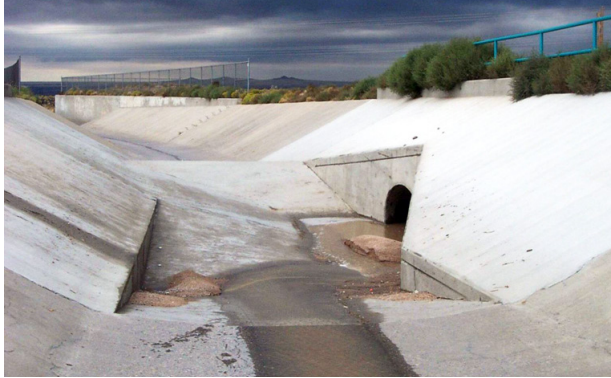
Figure 11. North Pino Channel Debris Intake Structure

I spoke earlier about our high-velocity system of channels. Peeling water off the side of a super-critical channel is a challenge. We have worked extensively with UNM's hydraulic laboratory and civil engineering department on this to the tune of \$50,000 a year. I'm sorry we can't also do that with NMSU. We have looked at ways to peel water off the channel without adversely affecting the 100-year-design flow. The setup in Figure 11 has worked pretty well. Freeboard walls have been added on either side, we have sunk the channel, and diverted water off the side. On our first one of these, we had an inlet dead center in the channel but we saw some safety concerns with that and hopefully someone could swim by a storm water quality diversion like this. That pipe runs over into a debris removal structure, this was designed by Bohannon Houston. The pipe comes in and was designed for mechanical maintenance. Figure 12 shows a hanging baffle and a weir so water comes in on the left bank, goes under the baffle, and over the weir so we get a really good capture of the

sediments and floatables behind the baffle. That way relatively clean water will go down to the secondary environmental pump. We have modified this design in different ways in different locations.

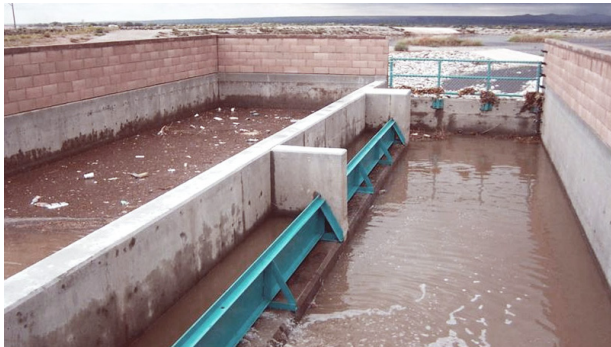
Figure 12. North Pino Arroyo Debris Removal Structure

We are now in our fourth generation of storm water retrofits. You will recall from Figure 12, the North Pino Arroyo Structure, that the system worked very well for floatables and sinkers but we had a lot of material that was suspended in the storm flow coming over the weir and running into the secondary pond. Jerry Lovato from our office had been to a storm water conference in Denver four years earlier and he came back with one heck of an idea. We used the coanda screen technology, which uses a wedge wire screen with a half-millimeter spacing between wedge wires. This screen allows little slivers of clean water to

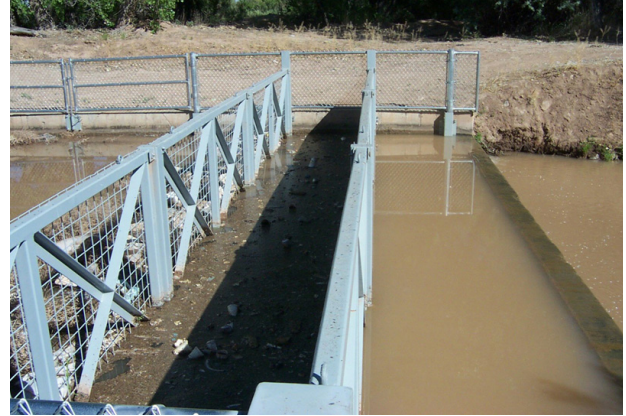
Figure 13. La Orilla Outlet Debris Baffle

Figure 13 shows the La Orilla outlet debris baffle; this is where it runs into the Rio Grande. This is a joint use facility with the MRG where we bleed storm water into it from Alameda Road all the way down almost to Montano. We designed this with the hanging baffle and the weir (the weir was already in the structure) and you can see how effective it is at removing trash before it gets into the river. A really easy way to do this is within a manhole (Fig. 14). In a typical storm drain manhole, one pipe going in and one pipe going out. We decided to put a sump in the manhole and a tee on the outlet pipes so the water has to come in, go under the tee, resulting in capturing the floatables. Then if someone forgets to maintain it (this thing is out of sight and out of mind), the water will go over the top of the tee and you have not compromised the flood control function. For this to work very well, however, you must use a vacuum truck for maintenance.

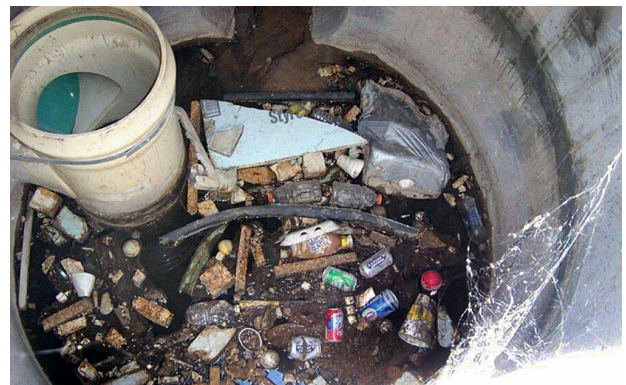
Figure 14. By-Pass Manhole Debris Containment after One Year of Operation and Before Maintenance

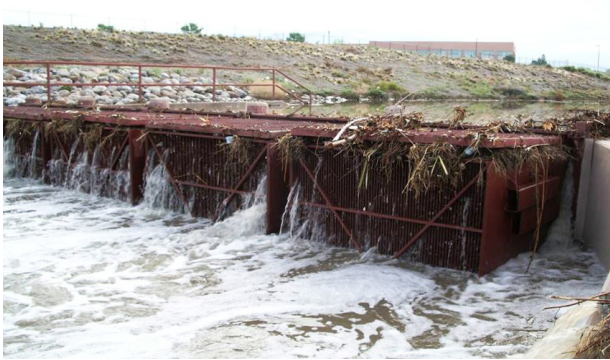
Figure 15. Bear Canyon Arroyo Debris Screen

In our Bear Canyon Arroyo (Fig 15), we looked at a system that the City Refuse Dept. could maintain. We placed screens across the arroyo as we had excess capacity in the channel because of upstream dams. The screens are set up so the City can come in with their normal refuse truck and empty the screens. These work fairly well but you end up taking to the dump 68 percent large and small natural vegetation.

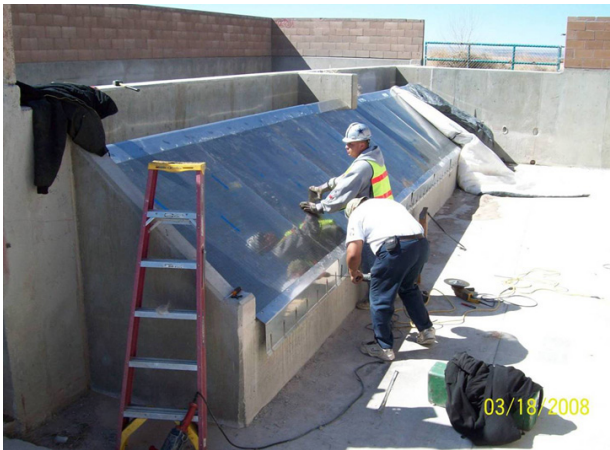
Figure 16. Coanda Screen Installation over New Clean Water Gallery

be shaved off as the water flows down it (Fig 16). It works in a vertical or incline setting. You have moving water flowing down, sort of like a cheese grater in reverse because as it slices off slivers of clean water, the trash and debris continue rolling down the screen. Figure 17 shows the screen functioning as you can see the water coming over the weir and dropping into the first six inches of the screen. The half-millimeter spacing will take 1 cfs per square foot, which is a heck of a flow rate, and you can see the trash rolling down the screen here.

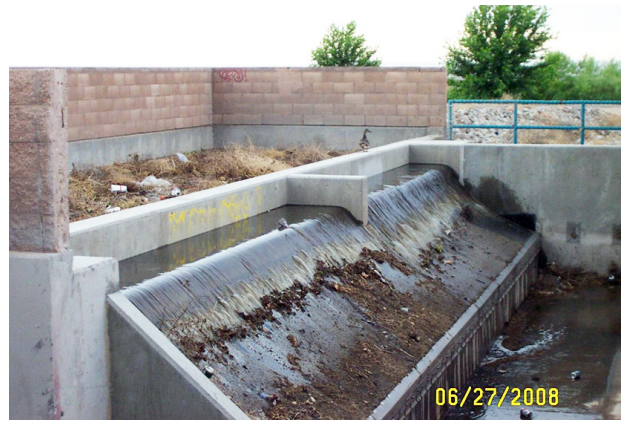
Figure 17. North Pino Coanda Screen Operation

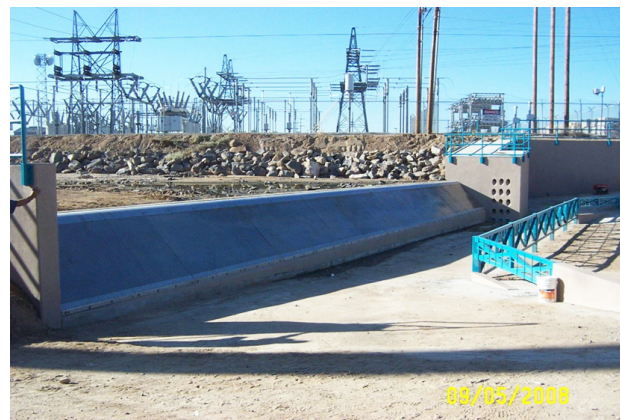
Figure 18. Vineyard Arroyo SWQF Complete

We have set up a similar but bigger project on the Vineyard Arroyo where the screen crosses the entire arroyo before flows make their way into the North Diversion Channel. The screen is sized for the 10-year-event coming down the arroyo (Fig. 18). Figure 19 shows what happens after a storm. The system has been on the ground for one full season, and you can see that water from a small storm came over just enough to come down and drop through the screen. You can see the debris washing down the stream and onto the screen. We have been critiqued by EPA about doing these end-of-pipe treatments, and they want to know why the program isn't up in the watershed, or why it isn't keeping the streets cleaner, or cleaning drop inlets more. The reason is that those are roles for the City, UNM, and the New Mexico Department of Transportation (DOT) in the storm water program; we are confined to the property and facilities we have.

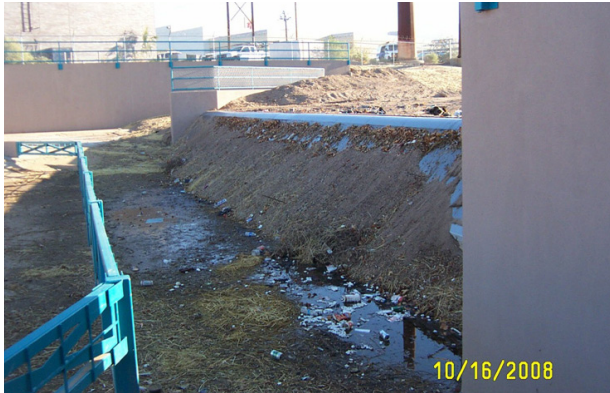
Figure 19. Vineyard Arroyo SWQF After Storm

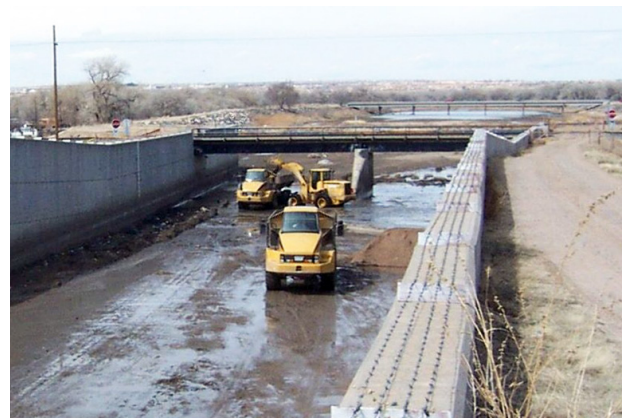
Figure 21. Sediment Removal at North Diversion Channel

We do several things to take care of bacteria as well as heavy metals. Many storm water pollutants are bound to sediments and our sediment removal program removes a lot of that right out of the system. Many of our projects have constructed wetland areas that slow the water down. Figure 21 show sediment removal at the North Diversion Channel. Figure 22 shows the long vegetated swale we created going through the entire inlet to the North Diversion Channel. If we slow water down and get some UV on it, you will knock the fecals out. We have done the same at our North Pino Pond where we have built a secondary environmental pond that serves as an extended detention pond. It allows us to slow the water down, drop out more sediments, and allows the sun to work on the bacteria. It works pretty well. We planted the pond with wetland vegetation to take up some of the nutrients and it does a good job. However, mallards live there and they contribute fecal matter to a storm water quality pond. It's one of those things where you try something and you get unintended consequences.

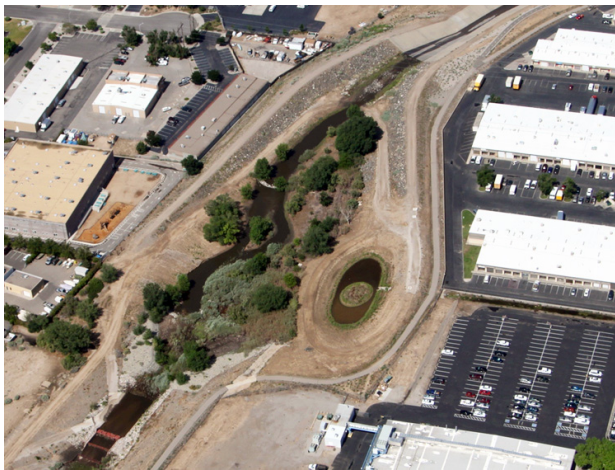
Figure 22. Bear Canyon Inlet Bio-Swales

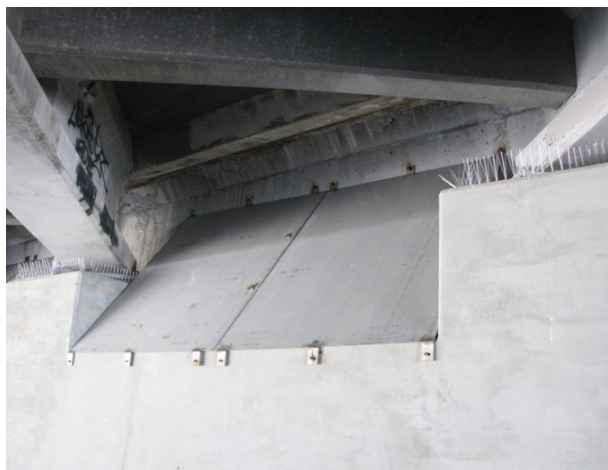
Figure 23. North Diversion Channel, Indian School Bridge Avian Control Project - Bird Spikes and Spiders

Referring back to Figure 20, we see that human sewage is 16 percent and avian sources are 34 of the total. We developed a project in one location where we were able to knock both those out. We had been looking at a demonstration project to deal with the pigeon problems on our diversion channels, primary at the bridges. We went to the police department and said, "We've got a real problem at Indian School Bridge over the diversion channel, it has turned into a homeless campsite." This area is close to UNM but far enough away where nobody was bothering folks sleeping under the bridge. And if they are sleeping under the bridge, you can guess what they do first thing in the morning. We went in with an Avian Control Project. You have seen the bird spikes and spiders on buildings; we put those on the bridge piers and portions of the abutments. But what was really successful was what we call bird slides. An abutment seat is about 6 feet long and 2 feet deep, perfect for your cardboard and sleeping bag. Figure 23 shows what we did: we put in a stainless steel bird slide so pigeons couldn't roost. It was fun watching them fly in and hit that stainless steel. They were like deer walking on ice. They cannot land and they just slide off. About

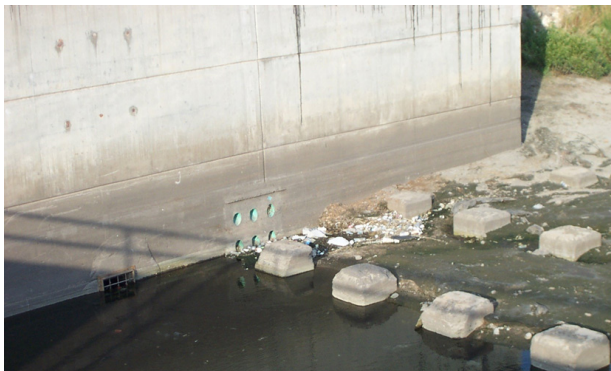
Figure 25. North Diversion Channel "Bathtub" Drains

concrete channel goes under the railroad bridge, through the outfall area, and past the levee into the river. The fish kill was in the embayment area. We looked at this and decided the problem was the bathtub drain area where the channel drops five feet to go under the railroad bridge. The water in that area is known to get stagnant. The theory was that this water had been pushed down the channel displacing water in the embayment area. That's why the DO dropped and caused the fish kill. What did we do? We opened the existing drain in the bathtub area and instead of keeping it closed as we would normally, we opened it to keep water flowing through the sink of stagnant water. It also made sense to put another drain in. Figure 25 shows the new drain and we thought we had the problem solved.

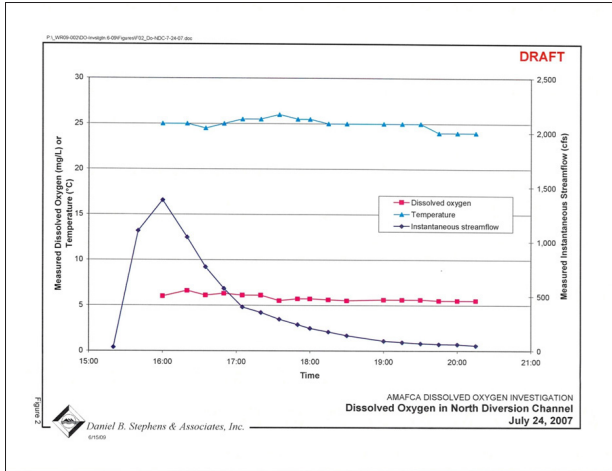
Figure 27. Dissolved Oxygen in North Diversion Channel July 24, 2007

First we looked at the diversion channel and confirmed our storm water was full of oxygen, as it should be, as it rushes down the arroyo through drop inlets. Sure enough, the data shows DO at about 5 parts per million (Fig. 27). We looked at the embayment area again. The graph in Figure 28 provides the USGS results. You will note that we are all over the place with DO above 5, below 5. We then looked at the profile of the embayment area. Figure 29 provides the measured dissolved oxygen concentration; the top line reflects the top 18 inches of the pilot channel as we move through the channel from the river upstream and the lower line is the lower 18 inches. The lower 18 inches is deficient in DO. That's when we realized we did have a problem in the embayment.

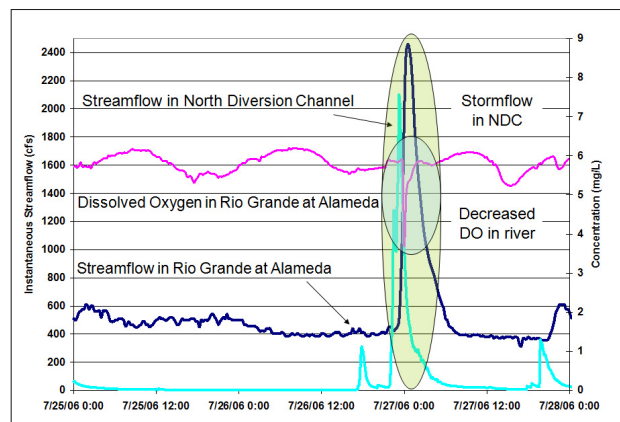
Figure 30.

We looked again at the provisional water quality data from Van Horn (Fig. 30). The stream flow in the Rio Grande is the dark line and stream flow in the diversion channel is the lighter line. It's easy to see the response here. Following a storm, the diversion channel spikes followed by a spike at the Rio Grande at Alameda shortly after. You can see the data from a couple other storms that occurred over a five-day period. These results are what Van Horn found. But let's look at the next storm as shown in Figure 31. After the first storm, the DO dropped. We look at the second storm and the DO drops but there is no flow in the North Channel so something else is causing the sag and it is not necessarily the North Diversion Channel. Since Van Horn used 4-way probes, we looked at specific conductance as an indicator of salt in storm water. It should show up high from a natural arroyo system like the Jemez watershed, and it would be low for storm water in an embayment; rainfall has very low specific conductance. Look at Figure 32; you have a flow in the North Diversion Channel, with all that nice clean rainwater running down, and the specific conductance does drop (7/27/06). If we look over at the next storm, the specific conductance spiked (7/28/10), and that is the indicator that we had something coming down from upstream. We don't know if it was wash from the Jemez because we haven't checked or had gauges on those. Could it be from the Montoya's? Could it be from Rio Rancho?
