## 2016 Oral Abstracts

### 1989 – Memories from the Sunnyside Mine

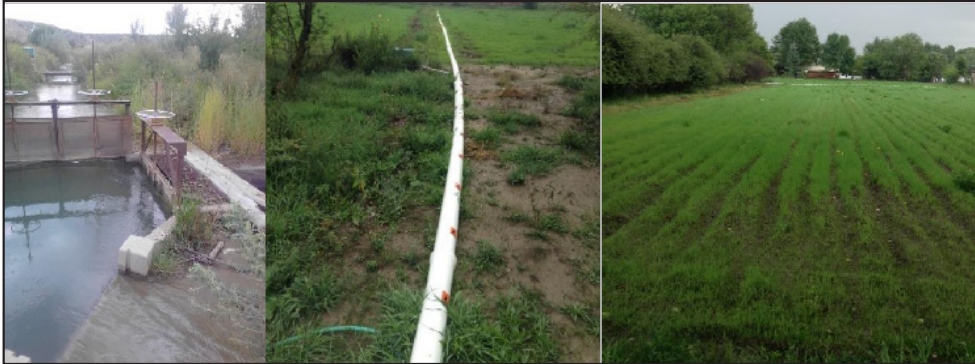
Typical furrow irrigated system in San Juan County, NM.

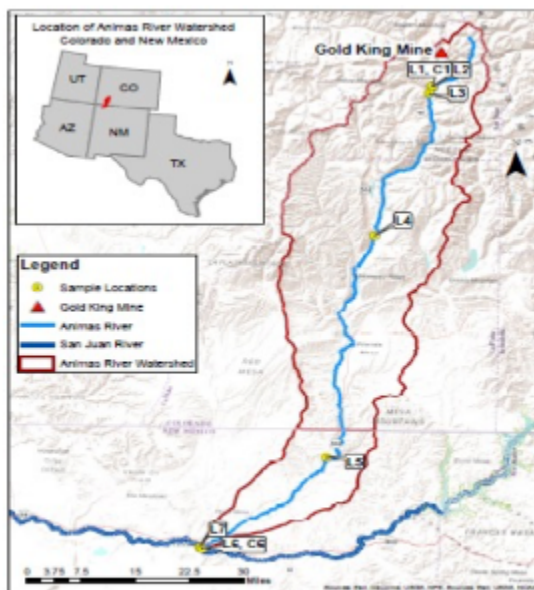
**Figure 1:** 8/17/15 – 8/18/15 Sample Locations in Animas River Colorado and New Mexico.

L1	Cement Creek 14th St Bridge
L2	EPA A68 Silverton Animas upstream
L3	EPA A72 Downstream of Cement Creek
L4	Animas at Bakers Bridge
L5	Animas Cedar Creek
L6	Animas at Farmington
L7	San Juan River downstream

On August 17th-18th, 2015 The University of New Mexico visited sites shown in Figure 1 along Cement Creek, Animas River, and San Juan River. At these sites, sediment samples were taken to determine metals composition, and microbial communities associated with the sediment. Basic water quality parameters were also measured such as water temperature, dissolved oxygen, conductivity, pH and oxidation-reduction potential. Sediment samples were sent to Research and Testing Laboratory for DNA extraction and Illumina Next Generation Sequencing.

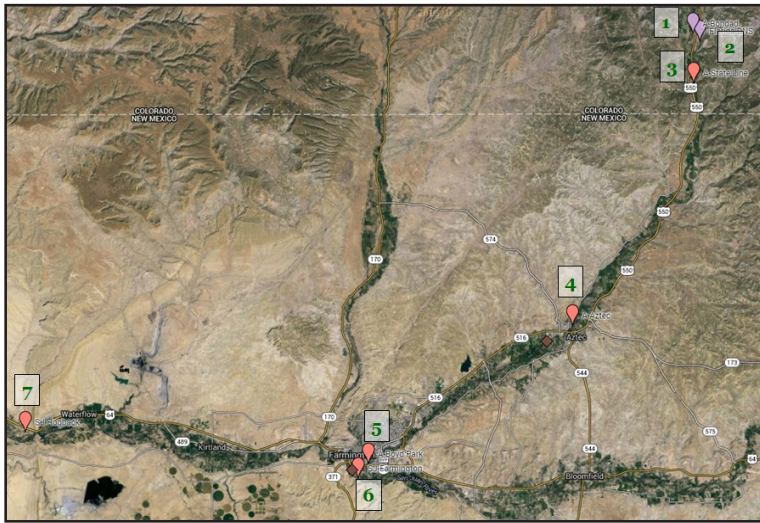
Figure 1. Map of 2014 sampling sites
